**Flood Control Project Maintenance
Levee Inspections**
LMA District Cover Sheet
Spring 2011 Levee Inspection Results

Reclamation District No. 2031 Elliot

Spring 2011 Levee Inspection Results

Waterway	Bank	Unit Miles
Unit No. 01 Stanislaus River	Left	7.15

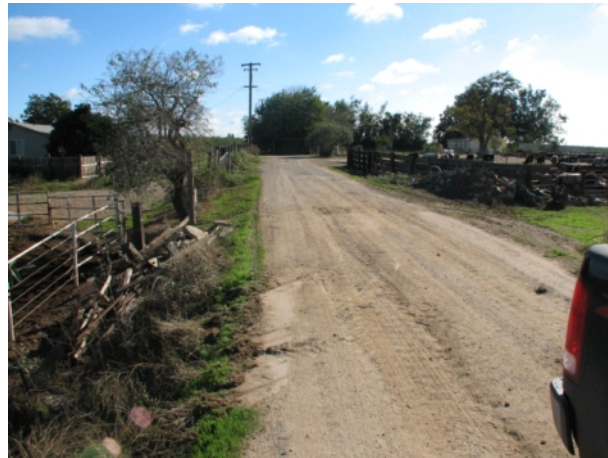
Levee Mile Report Line	1
Start Levee Mile	0.00
End Levee Mile	0.07
Location	Water Side
Category	Earthen Levee
Item	Encroachments

Fall 2009 photo looking upstream at beginning of unit 1. Water side to the left.

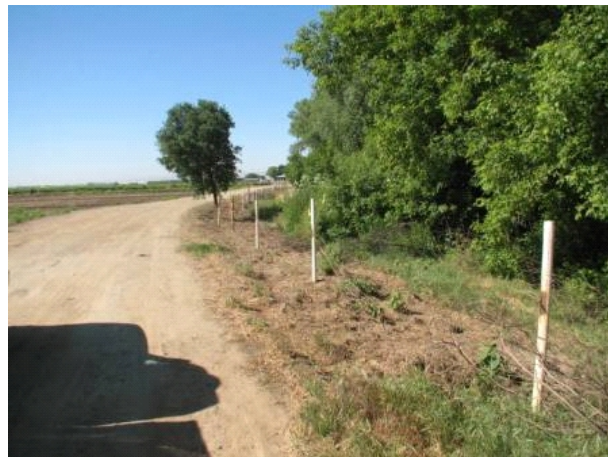
Levee Mile Report Line	4
Start Levee Mile	0.35
End Levee Mile	0.46
Location	Water Side
Category	Earthen Levee
Item	Encroachments

05/10/2011 Fence on waterside prevents access to waterside slope.

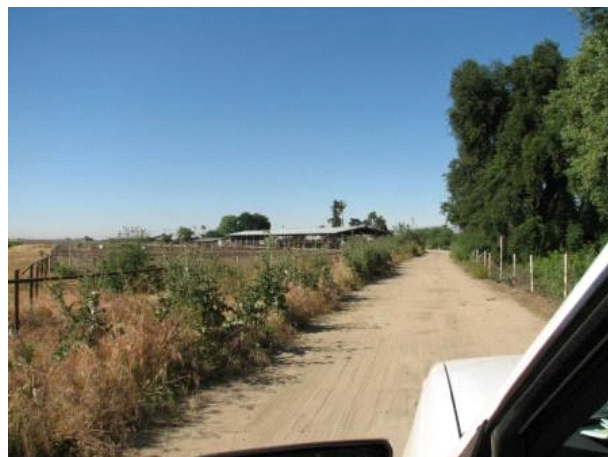
Levee Mile Report Line	7
Start Levee Mile	0.46
End Levee Mile	0.47
Location	Land Side
Category	Earthen Levee
Item	Vegetation

05/10/2011 Vegetation on landside prevents visibility of landside slope and toe.

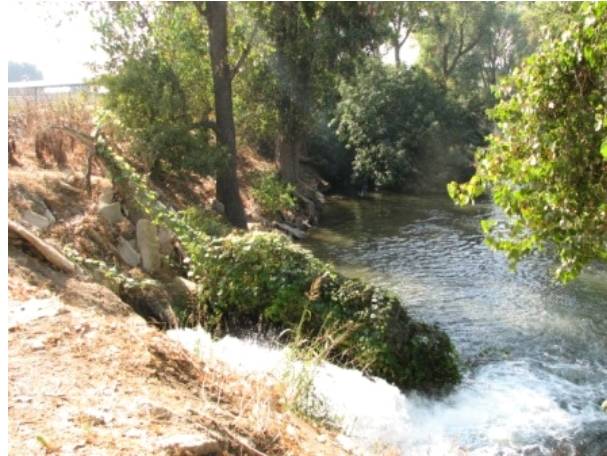
Levee Mile Report Line	8
Start Levee Mile	0.47
End Levee Mile	0.50
Location	Water Side
Category	Supplemental
Item	DWR Erosion Survey
Looking downstream of the site. Note the irrigation outlet is operational.	
jeto_s_20110301_095.jpg

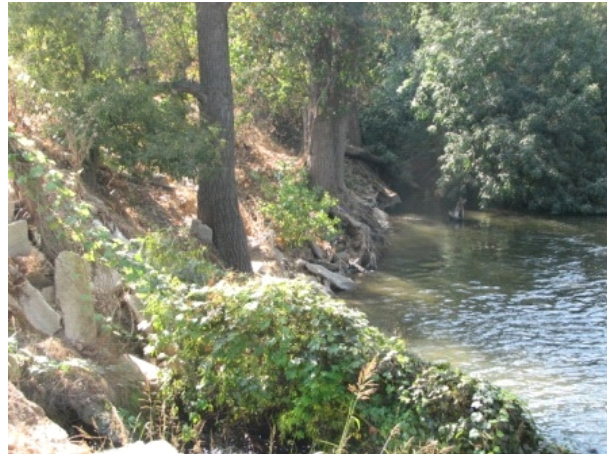
Levee Mile Report Line	8
Start Levee Mile	0.47
End Levee Mile	0.50
Location	Water Side
Category	Supplemental
Item	DWR Erosion Survey
Looking downstream of the site.	
jeto_s_20110301_096.jpg

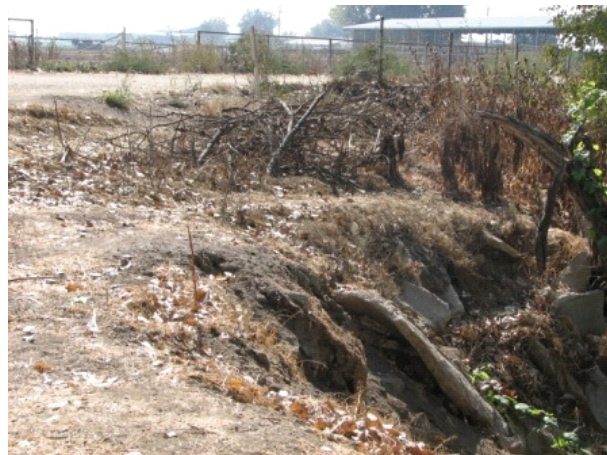
Levee Mile Report Line	8
Start Levee Mile	0.47
End Levee Mile	0.50
Location	Water Side
Category	Supplemental
Item	DWR Erosion Survey
View of the current condition of the levee slope just above the irrigation outlet.	
jeto_s_20110301_097.jpg

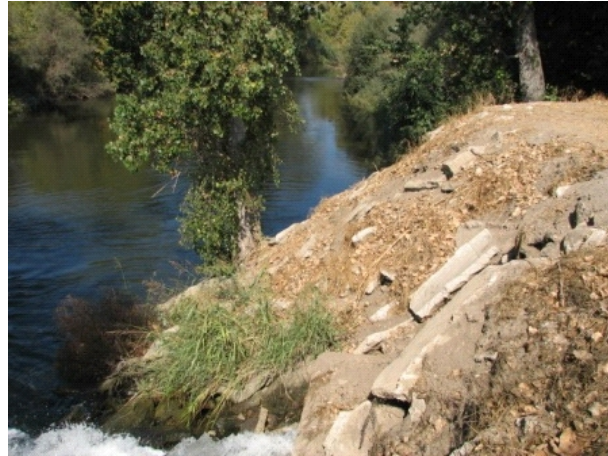
Levee Mile Report Line	8
Start Levee Mile	0.47
End Levee Mile	0.50
Location	Water Side
Category	Supplemental
Item	DWR Erosion Survey

Upstream view of the site.

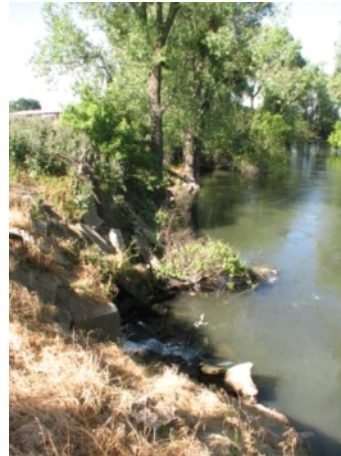
Levee Mile Report Line	8
Start Levee Mile	0.47
End Levee Mile	0.50
Location	Water Side
Category	Supplemental
Item	DWR Erosion Survey

05-10-21011 Updated view of erosion site, does not appear to be any change in conditions.

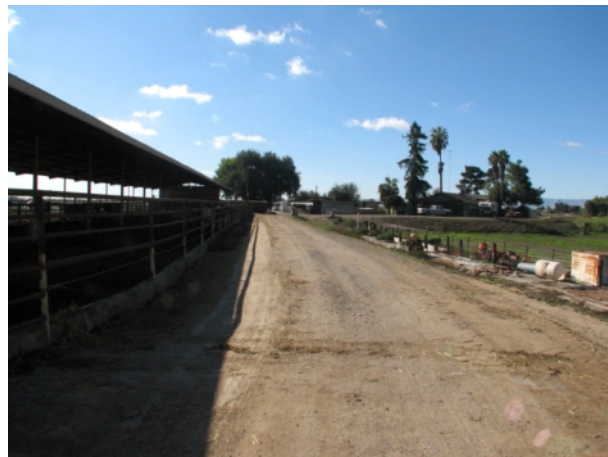
Levee Mile Report Line	10
Start Levee Mile	0.55
End Levee Mile	0.65
Location	Land Side
Category	Earthen Levee
Item	Encroachments

Fall 2009 photo of livestock pens and house on landside slope.

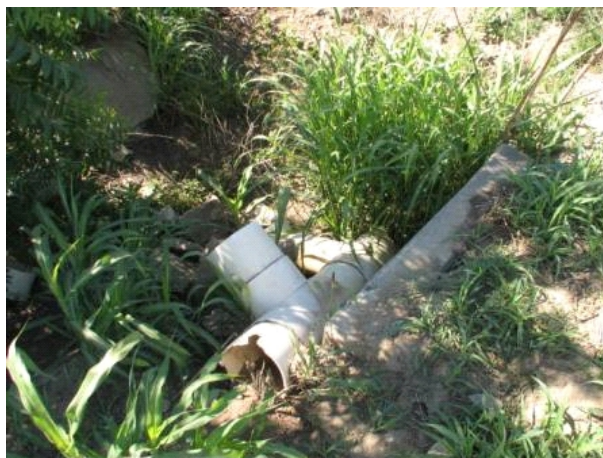
Levee Mile Report Line	14
Start Levee Mile	0.81
End Levee Mile	0.81
Location	Land Side
Category	Earthen Levee
Item	Encroachments

05/10/2011 PVC pipe pieces are obstructing opening to drain pipe.

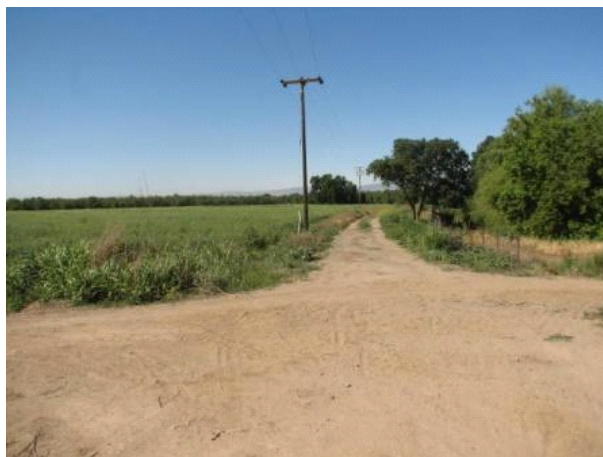
Levee Mile Report Line	15
Start Levee Mile	0.81
End Levee Mile	0.96
Location	Land Side
Category	Earthen Levee
Item	Vegetation

05/10/2011 Photo shows uncontrolled vegetation on both land and waterside of levee.

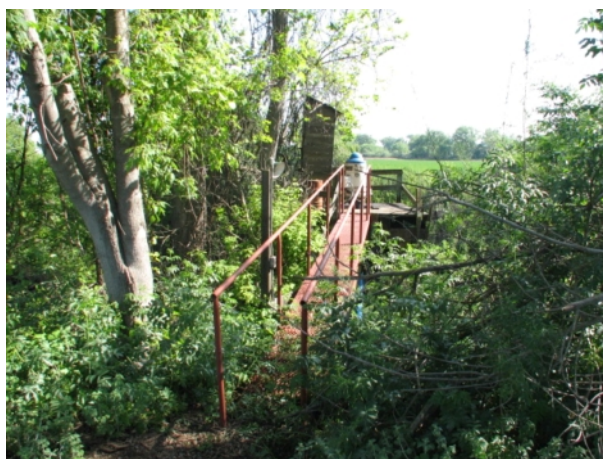
Levee Mile Report Line	20
Start Levee Mile	1.27
End Levee Mile	1.27
Location	Water Side
Category	Earthen Levee
Item	Encroachments

Irrigation intake pump and pipe.

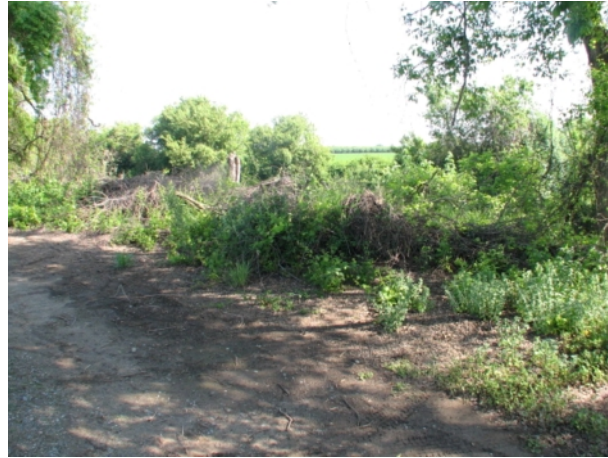
Levee Mile Report Line	21
Start Levee Mile	1.27
End Levee Mile	1.27
Location	Water Side
Category	Earthen Levee
Item	Vegetation

Vegetation on waterside slope and crown.

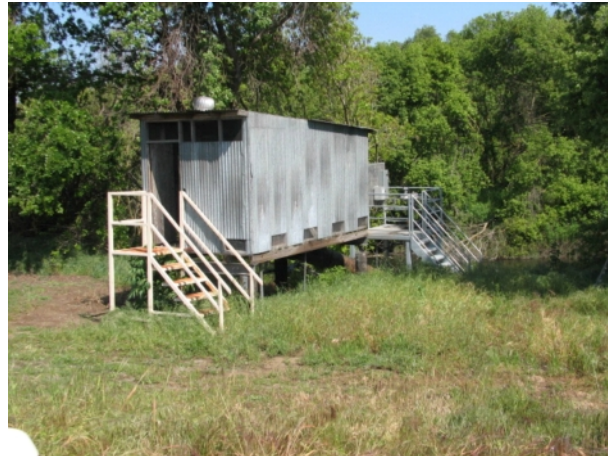
Levee Mile Report Line	33
Start Levee Mile	3.72
End Levee Mile	3.72
Location	Water Side
Category	Earthen Levee
Item	Encroachments

Irrigation intake on waterside berm.

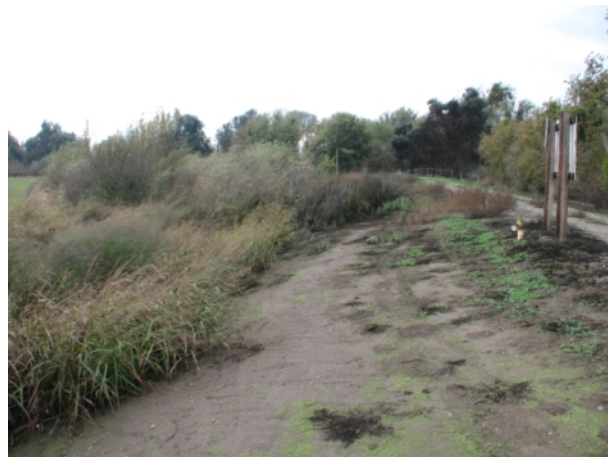
Levee Mile Report Line	36
Start Levee Mile	4.39
End Levee Mile	4.43
Location	Land Side
Category	Earthen Levee
Item	Vegetation

Obstructive vegetation on levee slope and within 10' of levee toe.

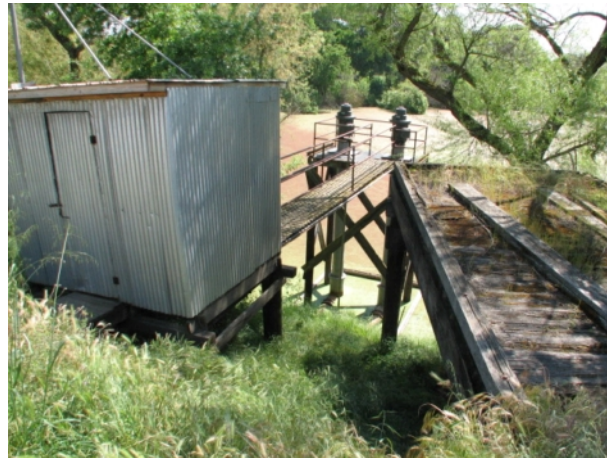
Levee Mile Report Line	3
Start Levee Mile	0.22
End Levee Mile	0.22
Location	Land Side
Category	Earthen Levee
Item	Encroachments

Drainage discharge pumps and housing on steep waterside slope.

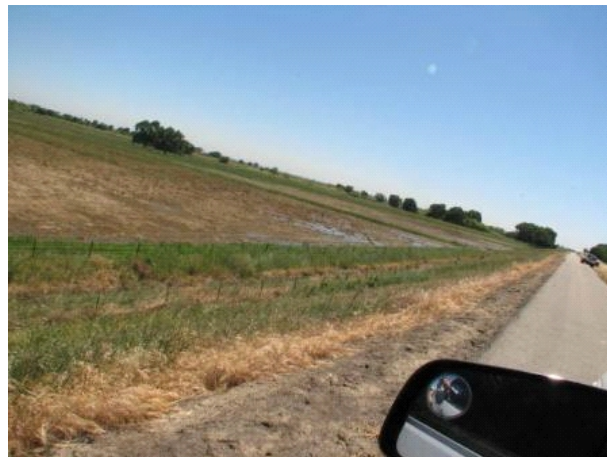
Levee Mile Report Line	4
Start Levee Mile	0.88
End Levee Mile	1.09
Location	Land Side
Category	Earthen Levee
Item	Seepage / Sandboils

05/10/2011 Seepage site shown, standing water in field.

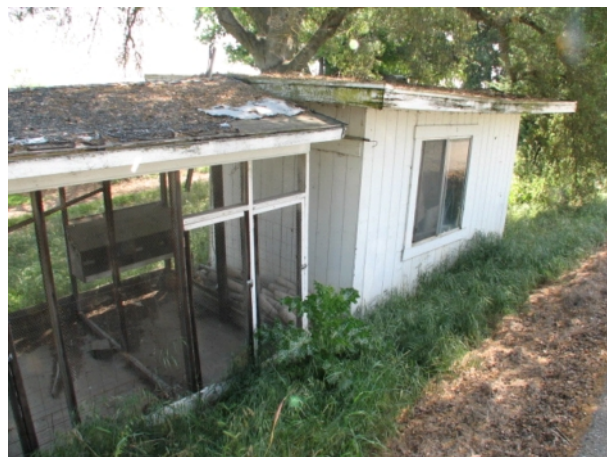
Levee Mile Report Line	5
Start Levee Mile	1.36
End Levee Mile	1.36
Location	Land Side
Category	Earthen Levee
Item	Encroachments

Small structure on levee slope.

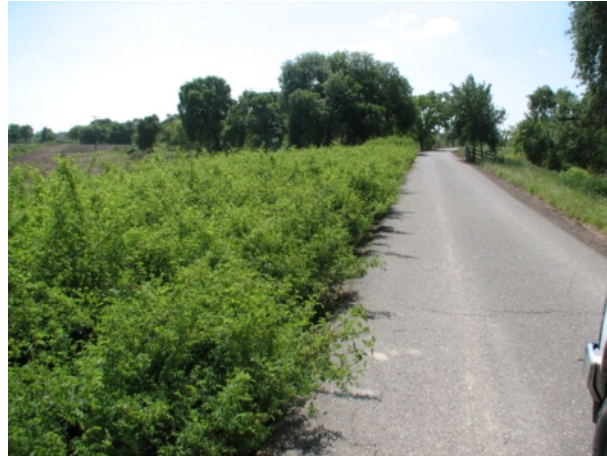
Levee Mile Report Line	6
Start Levee Mile	1.45
End Levee Mile	1.45
Location	Land Side
Category	Earthen Levee
Item	Encroachments

Wild rose on levee slope.

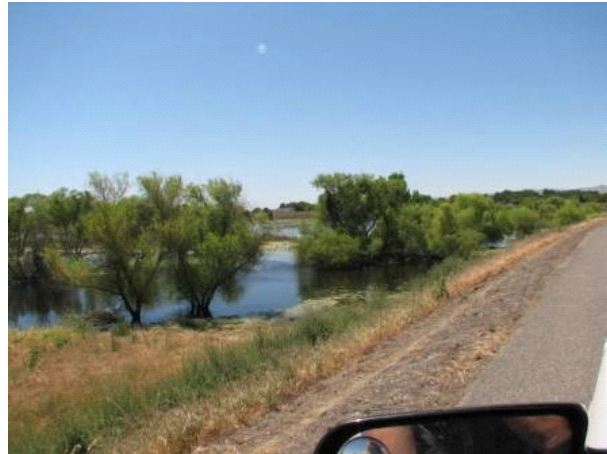
Levee Mile Report Line	7
Start Levee Mile	1.66
End Levee Mile	1.90
Location	Land Side
Category	Earthen Levee
Item	Seepage / Sandboils

05/10/2011 Seepage area shown, water to depths of several feet.

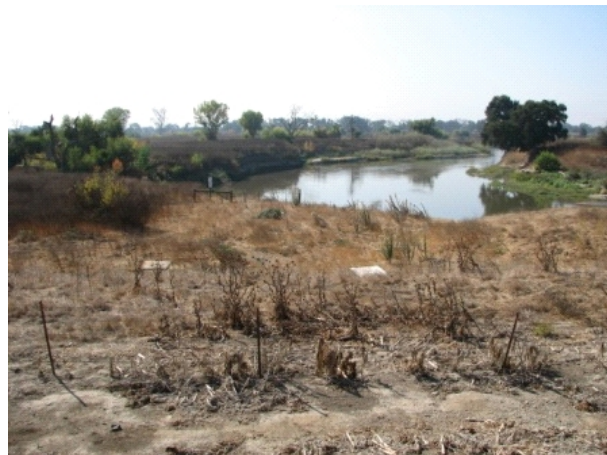
Levee Mile Report Line	11
Start Levee Mile	4.33
End Levee Mile	4.37
Location	Water Side
Category	Supplemental
Item	DWR Erosion Survey

From the berm looking upstream. Note the perpendicular approach of incoming flow onto the bank.

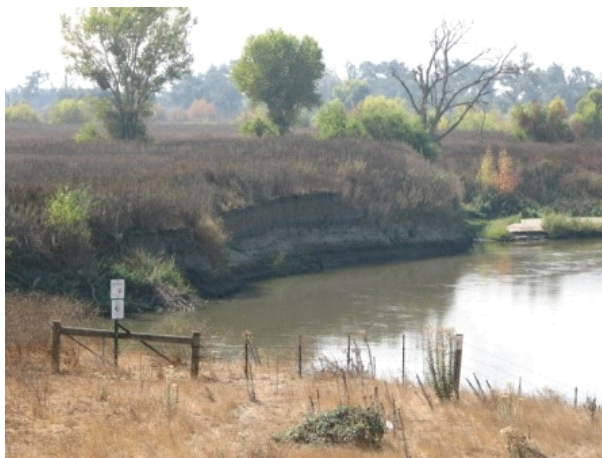
Levee Mile Report Line	11
Start Levee Mile	4.33
End Levee Mile	4.37
Location	Water Side
Category	Supplemental
Item	DWR Erosion Survey

Upstream view of adjacent bank affected by erosion.

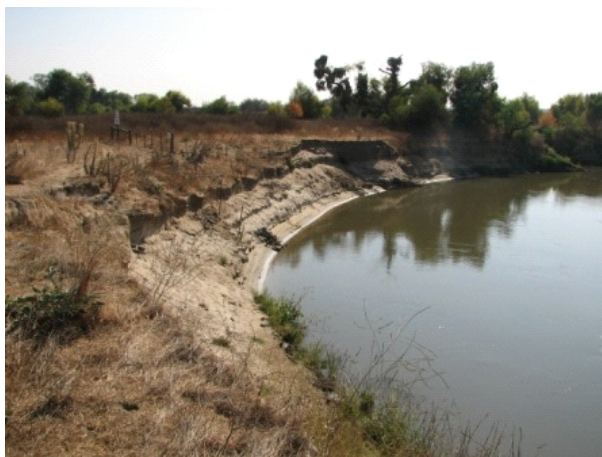
Levee Mile Report Line	11
Start Levee Mile	4.33
End Levee Mile	4.37
Location	Water Side
Category	Supplemental
Item	DWR Erosion Survey

Upstream view of scouring.
